# EFB CMA-1310 – Battery Swelling

ATA 46 - INFORMATION SYSTEMS

Revision	Date	Description
0	Jan 09, 2023	Original Publication
1	Feb 05, 2024	Availability of SB, release of EASA PAD
2	Mar 20, 2024	Release of EASA AD 2024-0072
3	Sep 10, 2024	Release of FAA NPRM 2024-2022
4	Apr 07, 2025	Release of FAA AD 2025-06-05

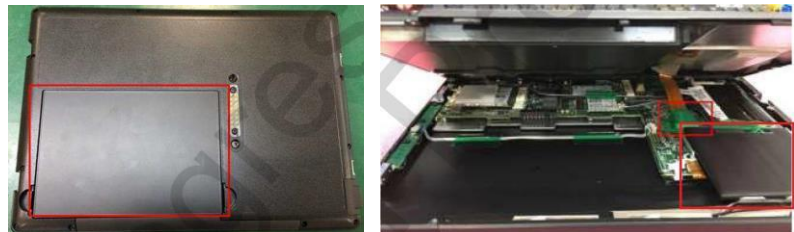
The EFB CMA-1310 has two lithium-polymer battery packs : one external removable pack, and one internal backup battery.

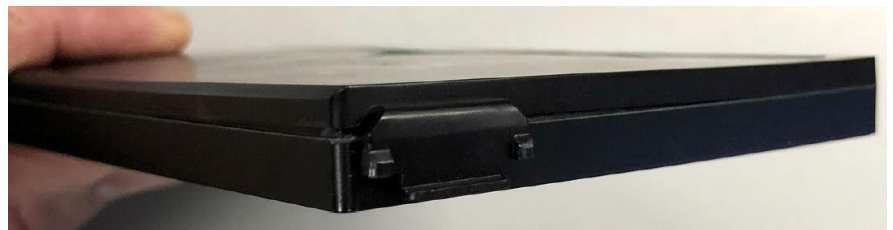
External battery swelling can be observed with visible deformation of the unit.

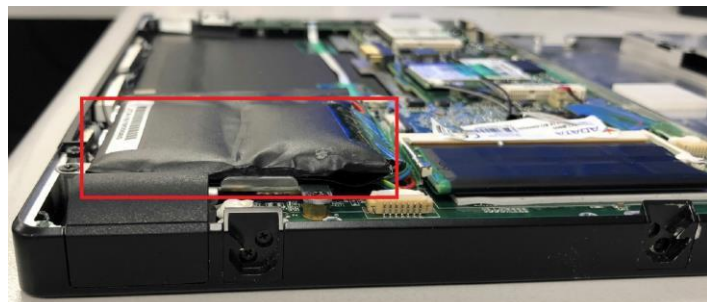
Internal battery swelling can damage the unit touchscreen or dislodge the LCD from the unit.

Occurrences of finding swelling of the lithium-polymer internal and external batteries of CMA-1310 EDU have been reported. The swelling occurs due to a high inrush charge and discharge current stress condition applied on a deeply discharged lithium-polymer battery.

This condition, if not corrected, could lead to the thermal runaway of a battery, possibly resulting in the release of heat, smoke, fire and explosion in the cockpit.

To prevent such situation Dassault Aviation has developed Service Bulletins 7X-632, F2000EX-507 and F900EX-614 to remove the internal battery from the EDU.
