CF34BJ SERVICE BULLETIN - 72-0347 R00
Revised:
05/30
/2025
SB 72-0347 R00 ENGINE - GENERAL (72-00-00) - ONE-TIME COMPRESSOR INNER DIAMETER INSPECTION FOR CORROSION AND VARIABLE GEOMETRY SYSTEM FUNCTIONAL CHECK
Issued: 05
/30/2025**GE Designated: -CONFIDENTIAL-**

SB 72-0347 R00 ENGINE - General (72-00-00) - One-Time Compressor Inner Diameter Inspection for Corrosion and Variable Geometry System Functional Check

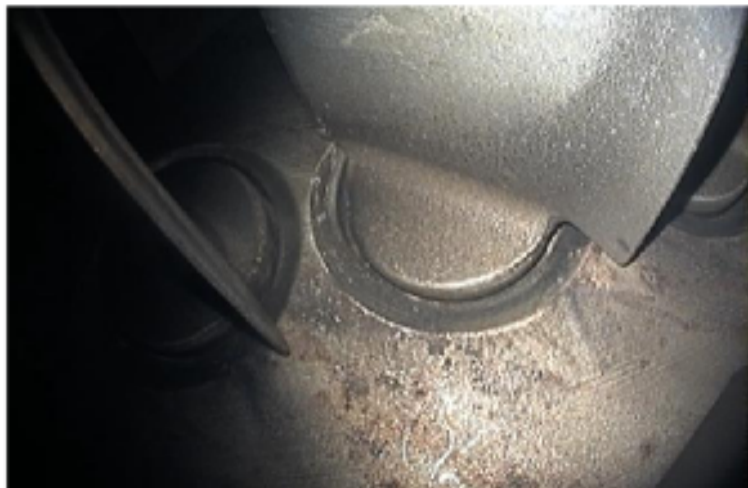
STAGE 5 CORROSION/PITTING INDICATION EXAMPLE

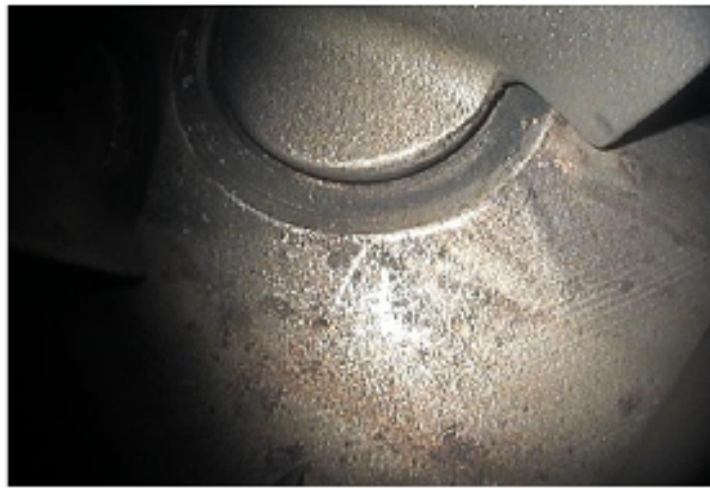
STAGE 5 CORROSION/PITTING INDICATION EXAMPLE

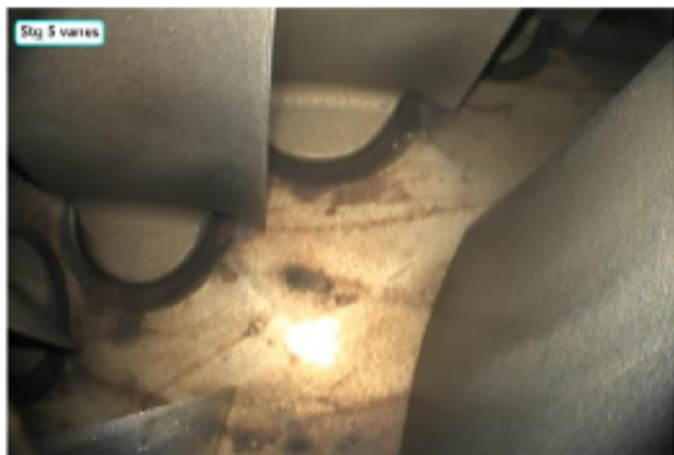
STAGE 5 ORANGE SPOT INDICATION EXAMPLE

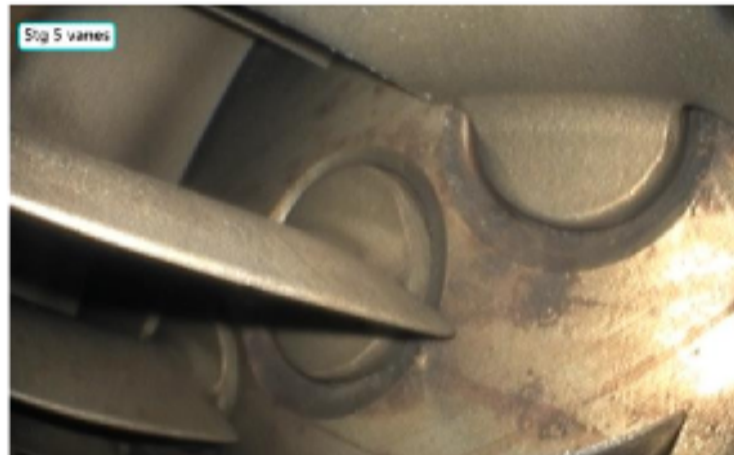
STAGE 5 ORANGE SPOT INDICATION EXAMPLE

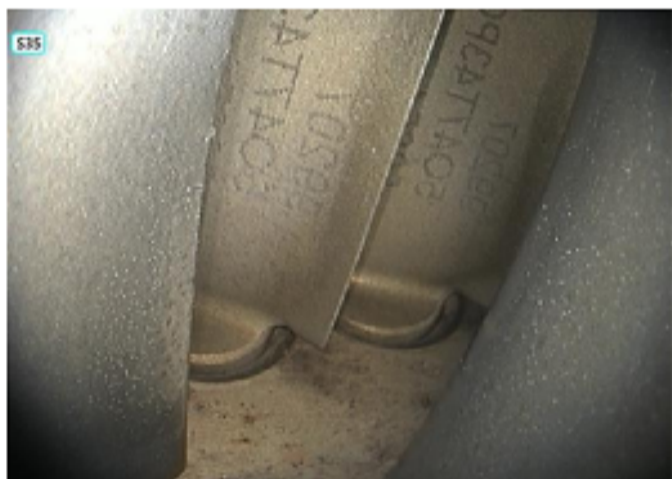
STAGE 5 CORROSION/PITTING INDICATION EXAMPLE

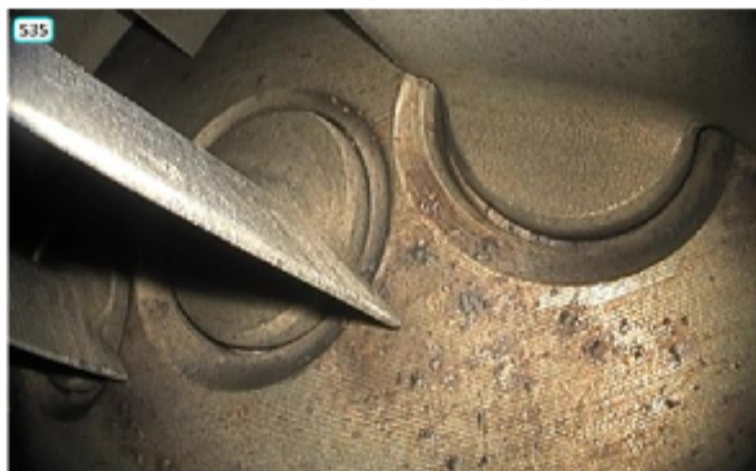
STAGE 5 CORROSION/PITTING INDICATION EXAMPLE

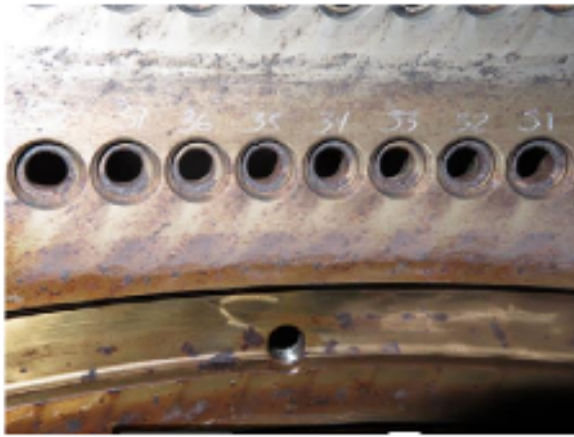
DISASSEMBLY CONDITIONS SHOWING CORROSION/PITTING OXIDATION FINDINGS (STAGE 5 AND STAGE 6)

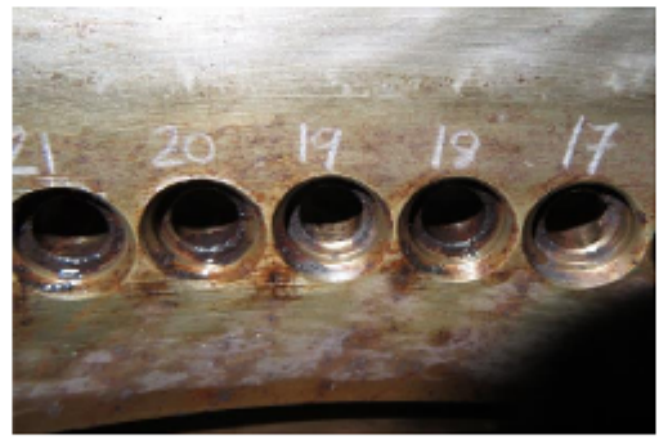
DISASSEMBLY CONDITION CORROSION PITS IN THE SURFACE OF INNER COMPRESSOR + EXAMPLE OF CORROSION IN VANE BORES

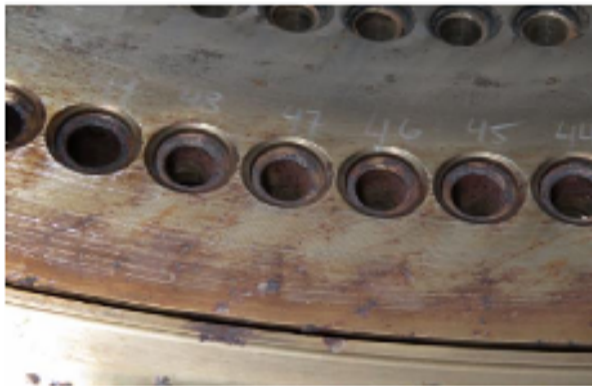
DISASSEMBLY CONDITIONS SHOWING CORROSION/PITTING OXIDATION FINDINGS (STAGE 5 AND STAGE 6)

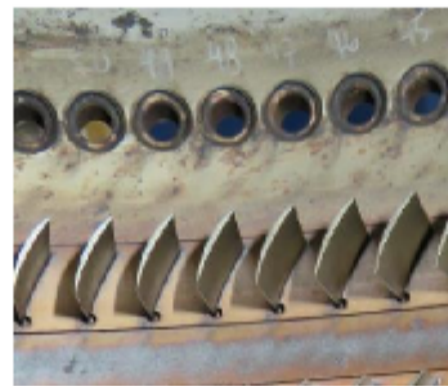
DISASSEMBLY CONDITIONS SHOWING CORROSION/PITTING OXIDATION FINDINGS (STAGE 5 AND STAGE 6)

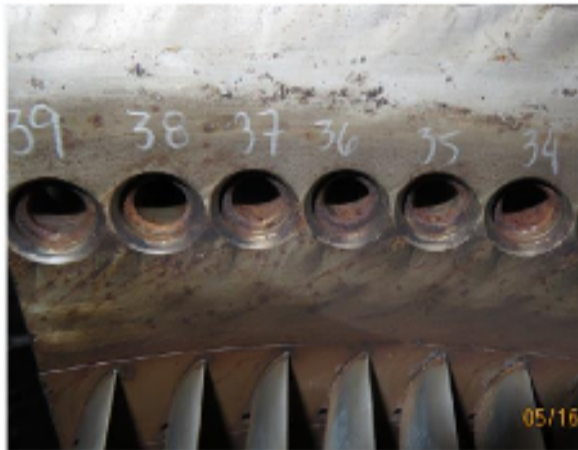
DISASSEMBLY CONDITIONS SHOWING CORROSION/PITTING OXIDATION FINDINGS (STAGE 5 AND STAGE 6)

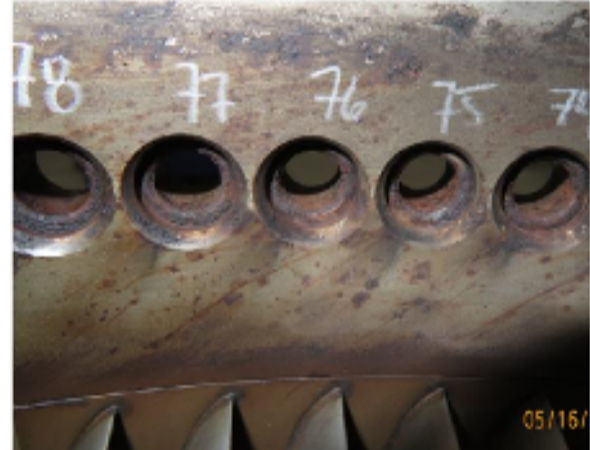
DISASSEMBLY CONDITION CORROSION PITS IN THE SURFACE OF INNER COMPRESSOR + EXAMPLE OF CORROSION IN VANE BORES
