SB525C-56-01

WINDOWS - WINDSHIELD AND COCKPIT SIDE WINDOW FRAME MODIFICATION

To add new windshield ground plates and sealing to the area around the frame of the windshields and cockpit side windows to decrease the potential for moisture incursion.

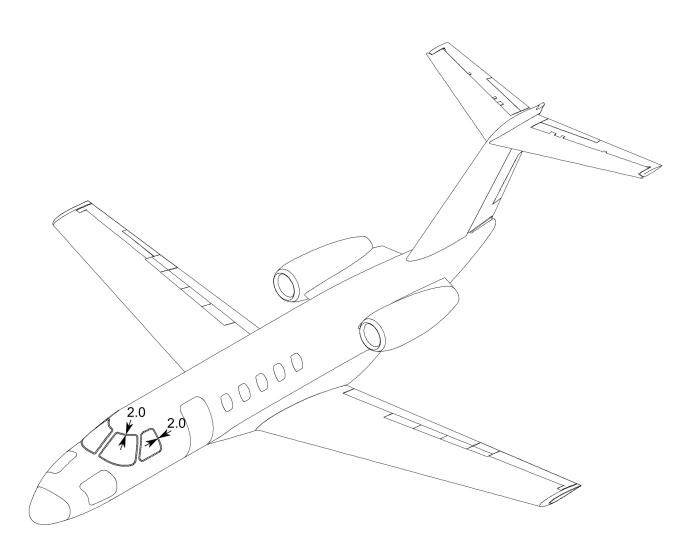
Figure 4. Windshield And Side Window Corrosion Inspection (Sheet 1)

Corrsion Inspection For The Left and Right Windshields and Cockpit Side Windows

- A. Remove any remaining fillet seal from the fuselage skin using best shop practices to prevent damaging the paint or primer.
- B. Visually inspect the fuselage skins and structure under and around the windshields and side window retainers and paint up to 2.0 inches outward from the edge of the retainers for bubbling, blistering or chipping of paint, or any signs of corrosion.

B. Visually inspect the fuselage skins and structure under and around the windshields and paint up to 2.0 inches outward from the edge of the retainers for bubbling, blistering or chipping of paint or any signs of corrosion.
