FALCON SERVICE BULLETIN

FALCON 7X

No 337-R1

REPLACEMENT OF BATTERY 1 NEGATIVE FEEDER

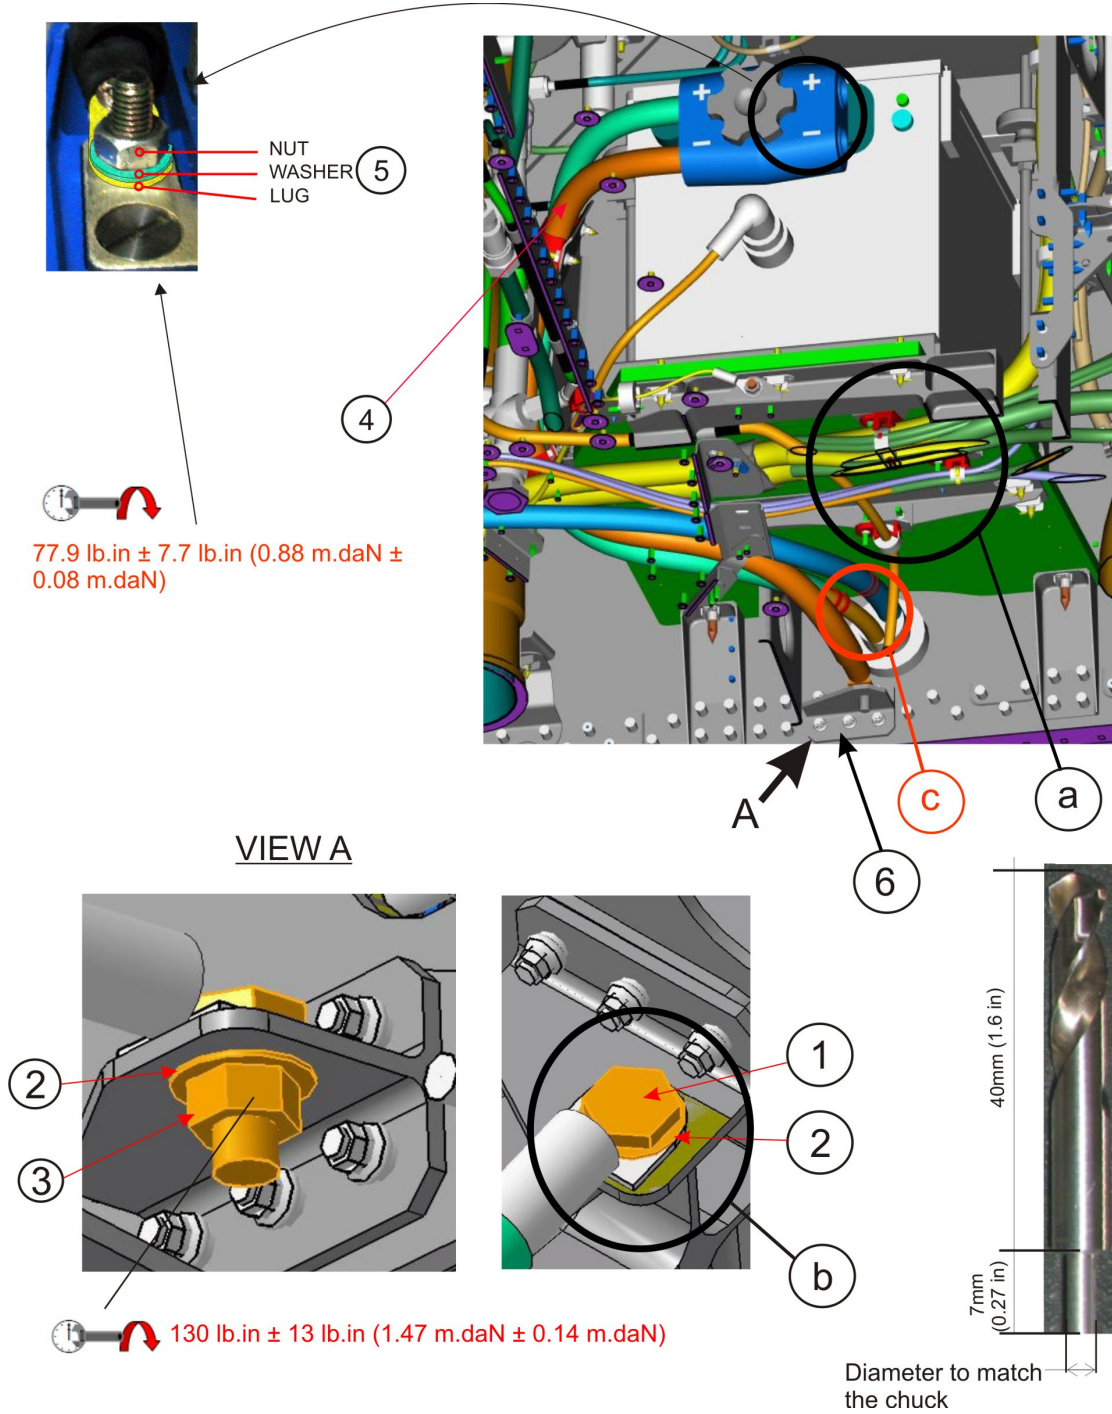
Figure 3: INSTALLATION OF LH NEGATIVE FEEDER

Evidence of overheat on the negative feeder terminal of battery 1 has been reported in service. This overheat may lead to disconnection of battery 1.

- (1) Removal of the BAT 1 negative feeder.
 - (a) Remove and discard the bolt/nut/washers of the LH negative feeder L1000PCT1.
 - (b) Open the battery plug, remove and discard the LH negative feeder and the washer.
- (2) Inspection of the LH negative feeder bracket (6-fig. 3)
 - (a) Inspect the LH negative feeder for signs of arcing or deterioration.
 - (b) If the bracket is damaged, replace it according to paragraph 4.
- (3) Installation of the new BAT 1 negative feeder (4-fig. 3)

- (a) In the plug (Refer to **IPC fig. 24-32-10-20**) item 10, install the nut with a new washer and tighten to a torque of 77.9 lb.in ± 7.7 lb.in (0.88 m.daN ± 0.08 m.daN).
- (b) Apply red **torque seal** and close the battery plug.
- (c) On the existing bracket, or on bracket P/N F7XC53555557A1, increase the hole diameter from 8.5 mm to 10.5 mm (0.335 in to 0.414 in) (use the short drill).

CAUTION: PROTECT THE FEEDER DURING DRILLING (C-FIG. 3).

- (d) Clean up the bonding area connected to the feeder lug (b-fig. 3).

NOTE: The bracket will be cleaned up by milling around the hole, on the two faces (diameter 24mm (0.945 in)) and on all the contact surface of the lug.

- (e) Install the lug with the new bolt/washers/nut assembly (1-2-3-fig. 3) on its bracket as follows:

- (f) Torque the feeder to 130 lb.in ± 13 lb in (1.47 m.daN ± 0.14 m.daN),
- (g) apply red **torque seal** on the nut/washer/bracket assembly,
- (h) apply **vinyl varnish** on all the surface to be protected.
