Outboard Trailing Edge Box Wing Rebate Flanges — Special Detailed Inspection

G450 AMM 57-50-00

GIV AMM 57-50-00

CMP 575019

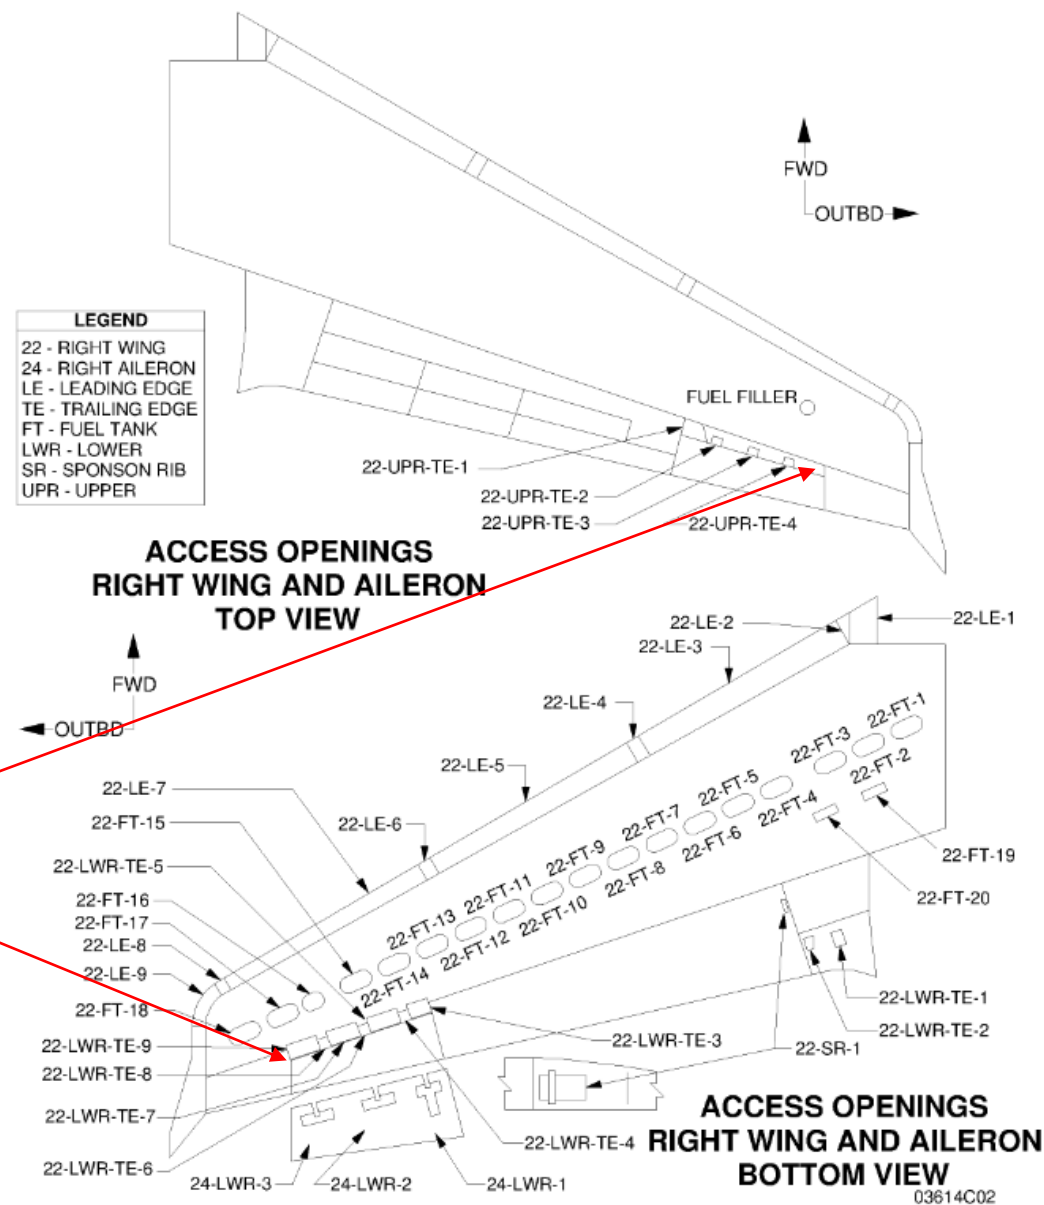
Inspection begins in vicinity of Right Wing RBS 433.000

Using a borescope, inspect wing plank from edge of rear beam flange to aft edge of flange to which trailing edge attaches

Crack begins approximately three inches outboard from borescope access point and continues for approximately 6 inches.

The left side of the picture is interface between the wing plank and the trailing edge box. The right side of the picture is the fasteners for the trailing edge box.

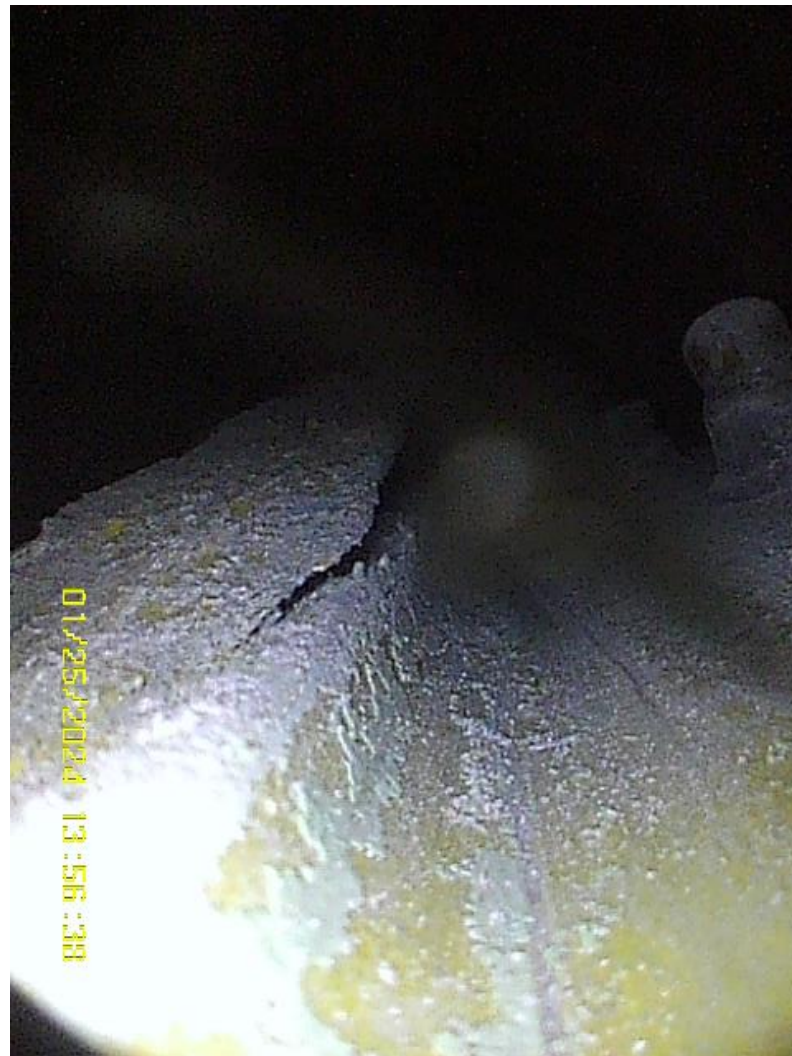
SEE DETAIL B

INSERT BORESCOPE INTO OPENINGS AND INSPECT WING REAR BEAM AND CAP ANGLES ALONG ENTIRE LOWER WING PLANK AREA. SEE INSET FOR SPECIFIC INSPECTION AREA.

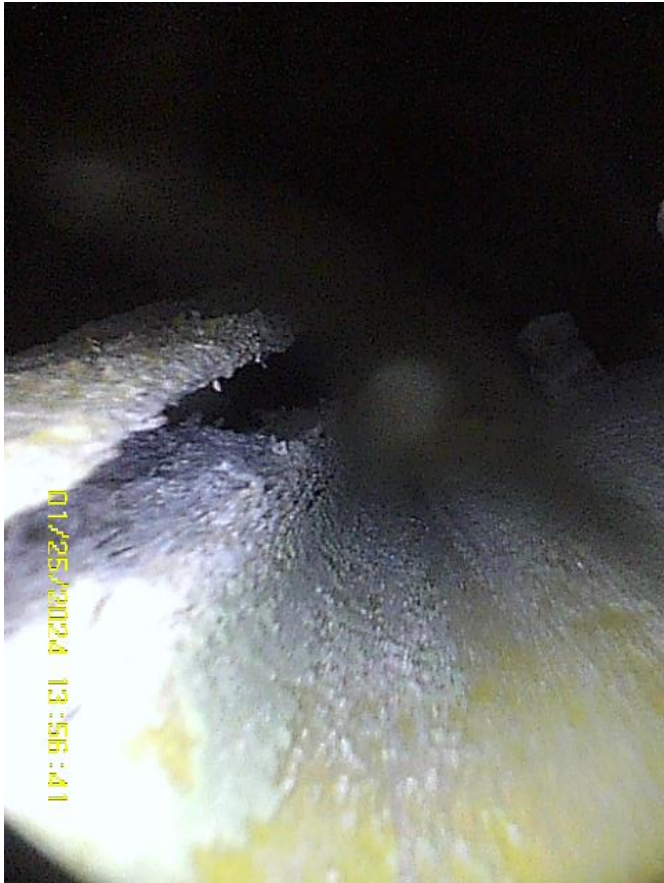
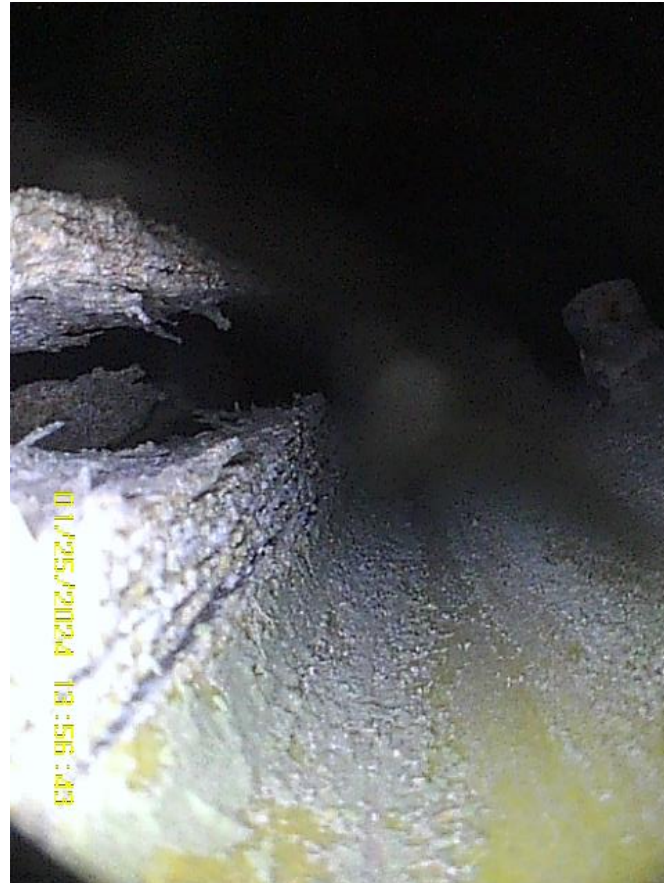
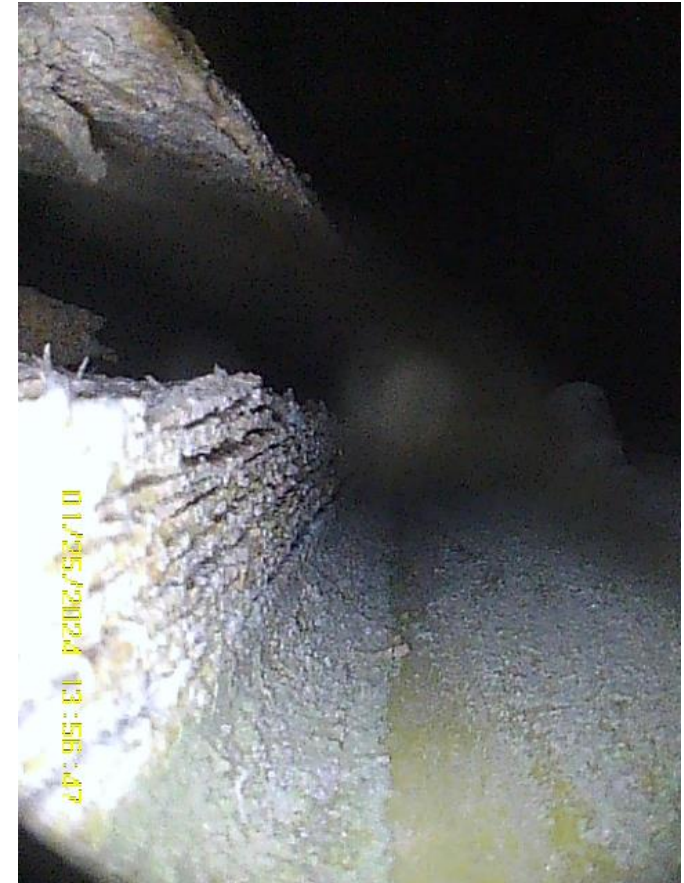
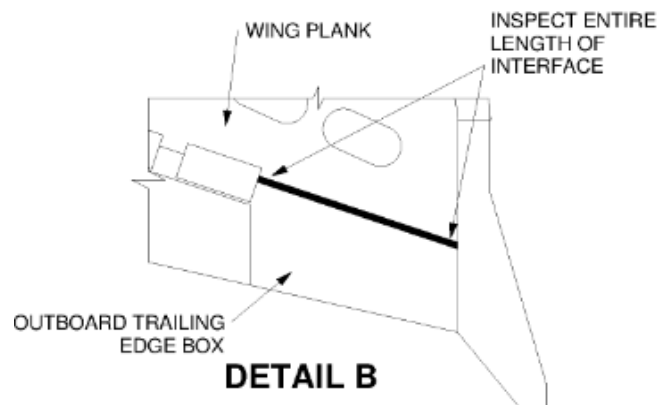
Exfoliation continues and approximately ½ inch gap becomes evident in the top material.

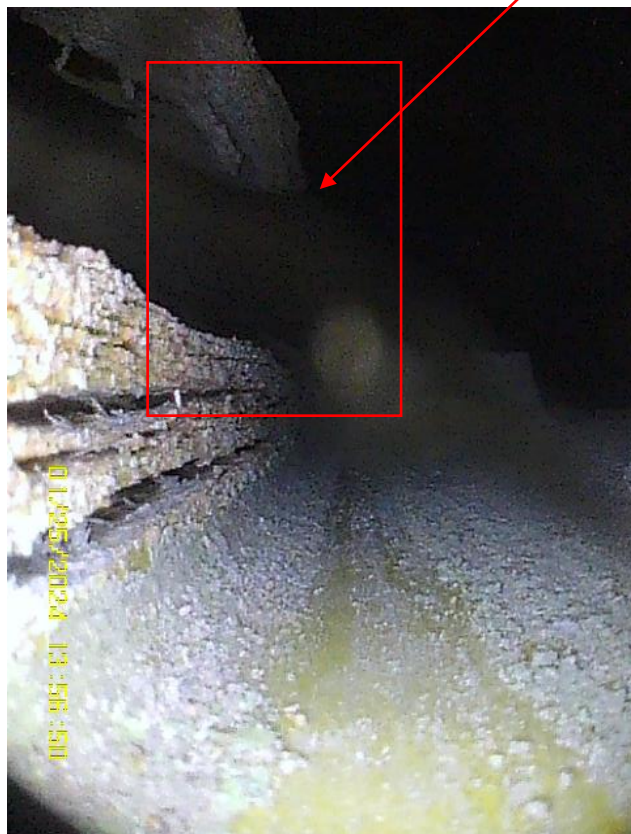
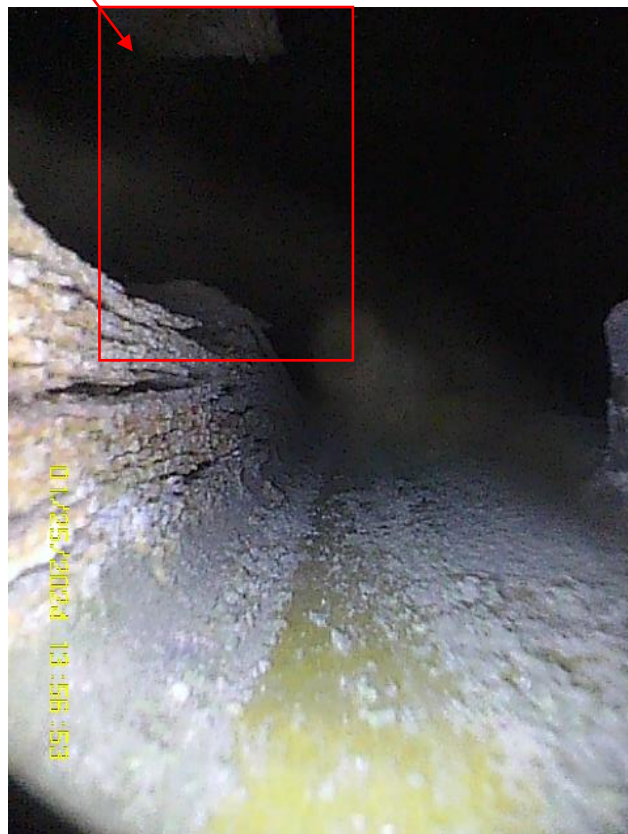
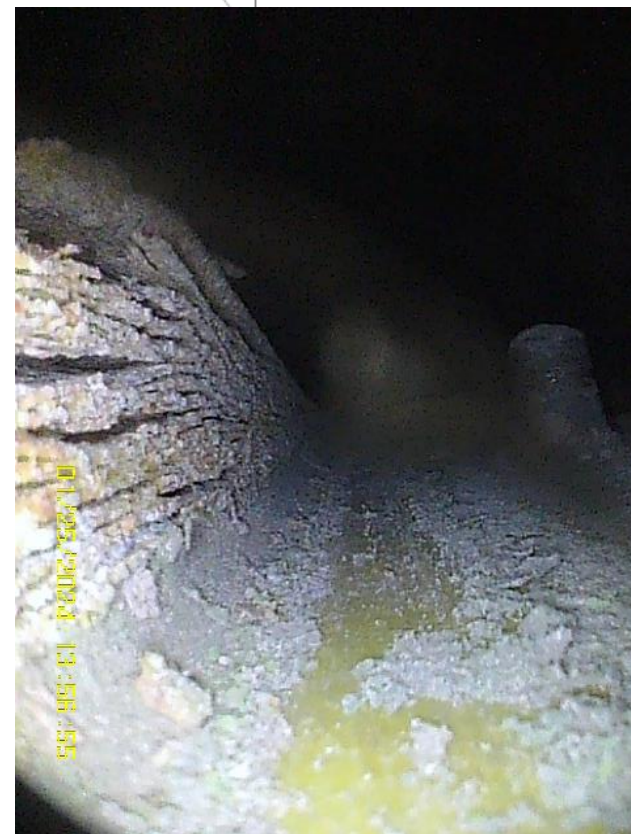
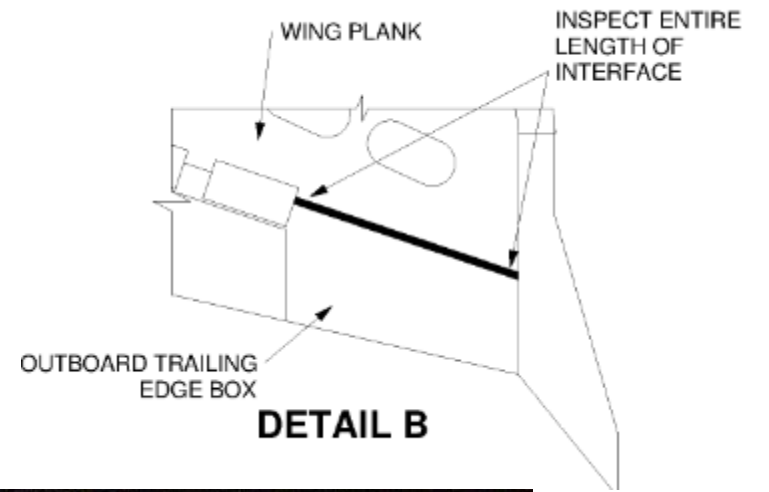
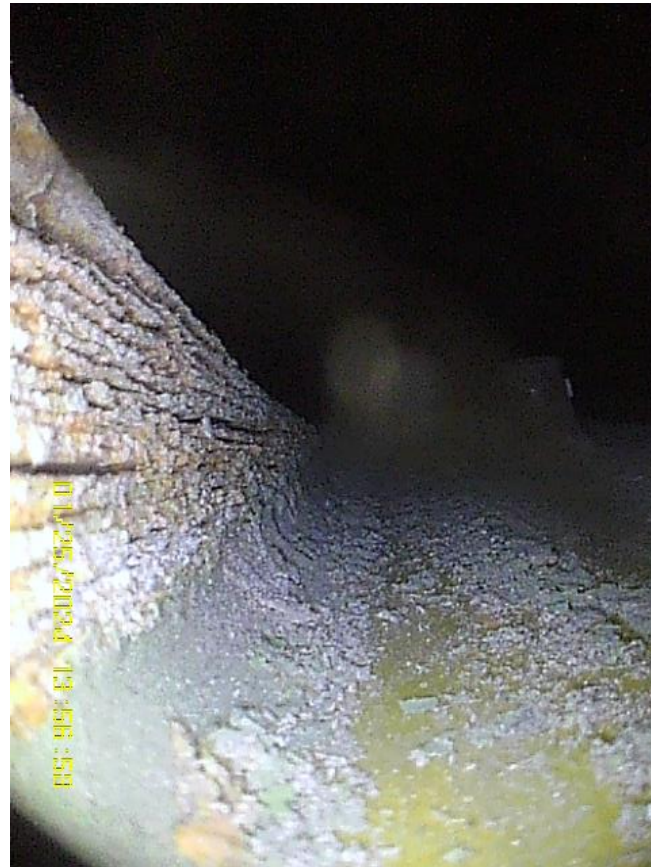
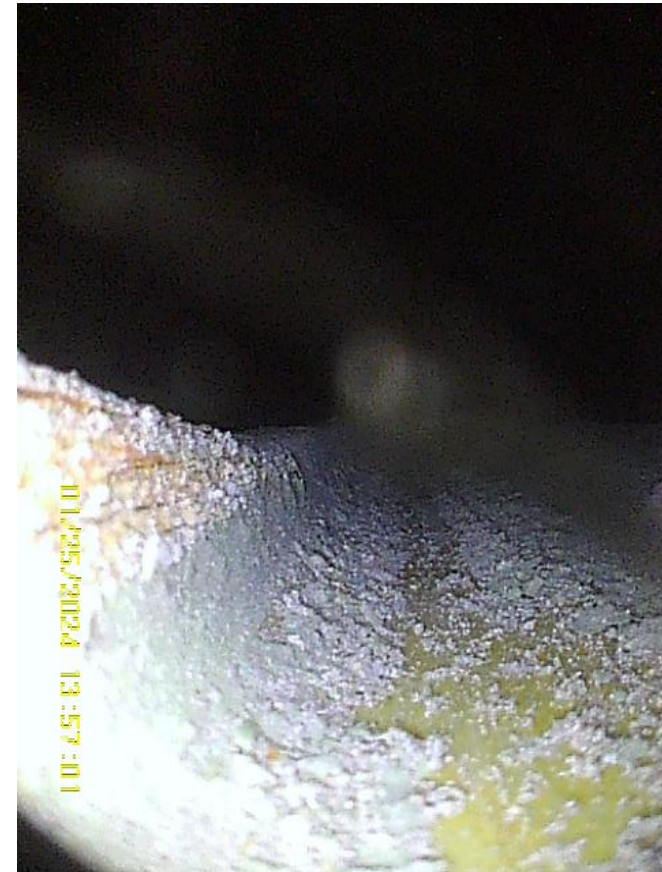
Approximately 6 inch from beginning of crack, exfoliation and crack stop.
