# West Star Aviation - Hawker 800/800XP/850XP Waste Drain Valve Modification

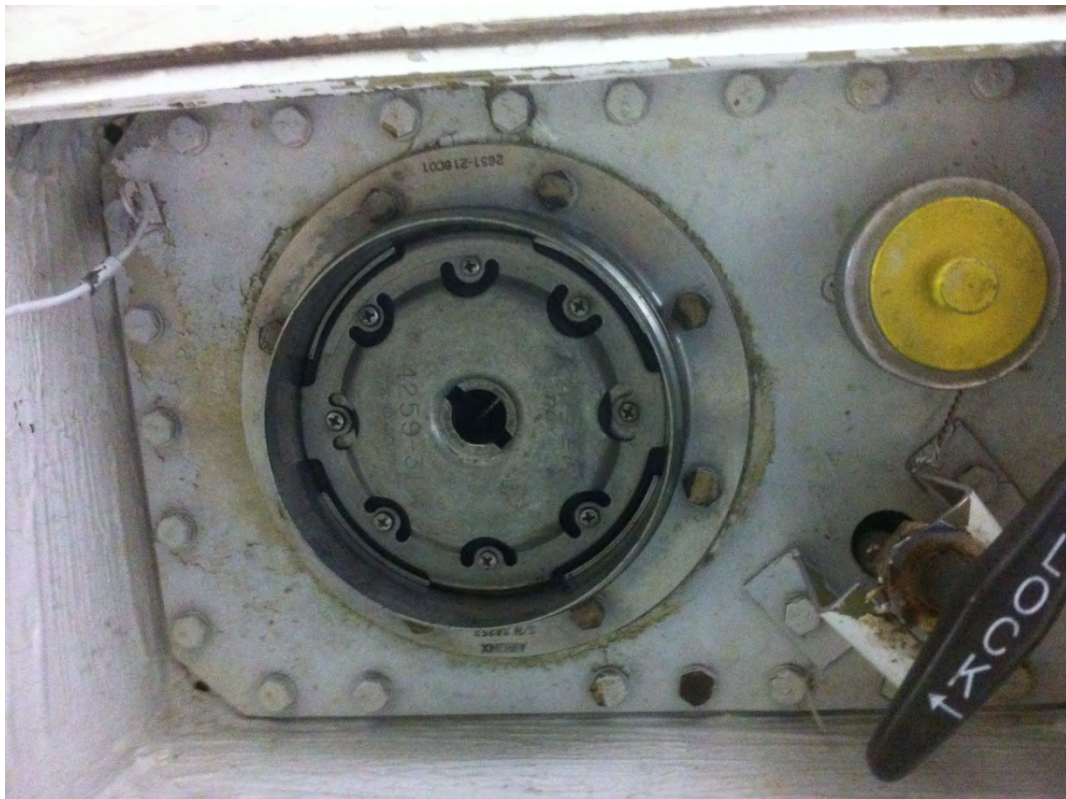
Hawker operators are all too familiar with the unpleasant task of draining the lavatory waste tank at the Ventral Fuel Tank Service Area. This has always been exasperated by the rather poorly designed external service cart connection that requires a T-Handle tool to remove the secondary pressurization plug or donut as it's often referred to.

If the valve in the lavatory tank is leaking, removing this plug means someone is in for...well, you know.

Often times ground service personnel will not get this plug re-installed correctly or forget it altogether. If this plug is missing, the MMEL for the Hawker states the aircraft is restricted to unpressurized flight and a ceiling of 15,000 ft. until it is replaced. This can cause dispatch problems of hours or days if you're in a part of the World where parts support is difficult.

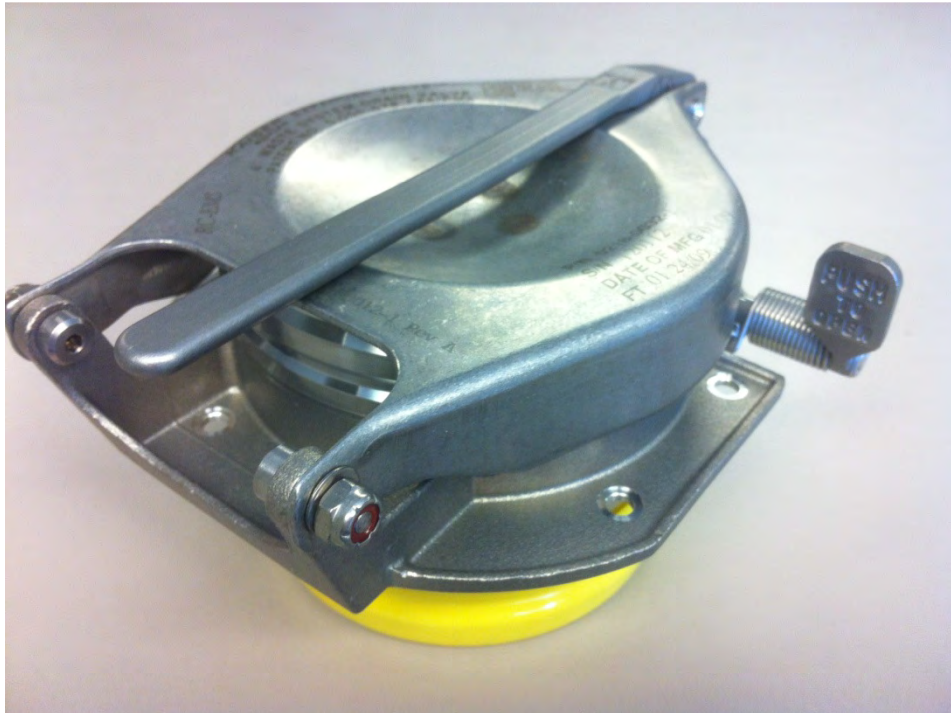
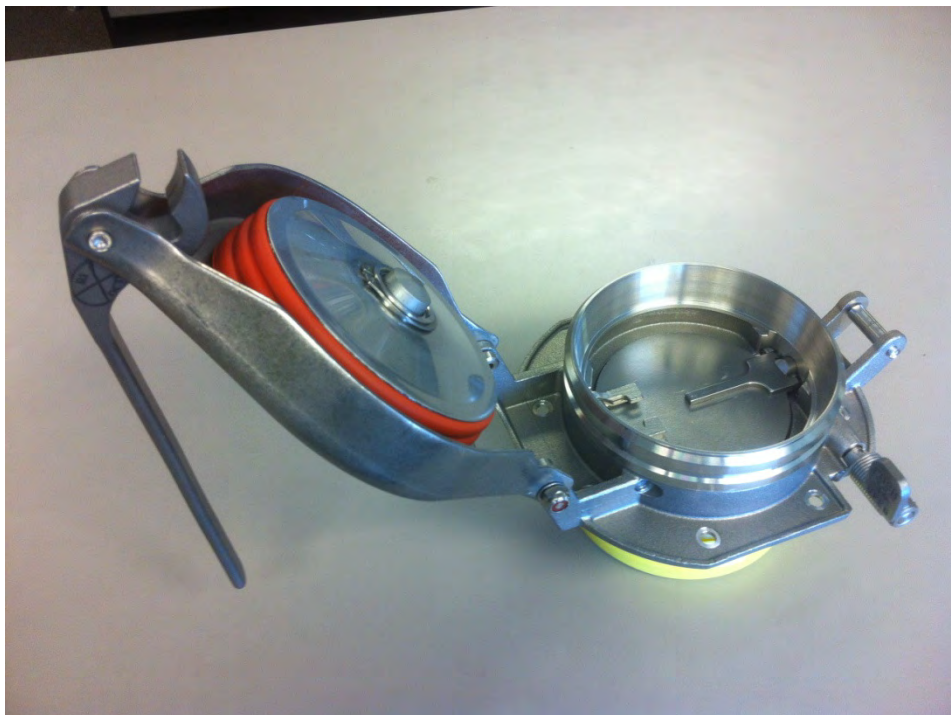
West Star Aviation has received approval to install a modern version of this service connection port which will eliminate these problems. Take a look;

Note the secondary pressurization plug is permanently built into the hinged cap that has an over center locking handle.

This modification can easily be incorporated with maintenance, avionics installation, paint or interior visits to any of our facilities.

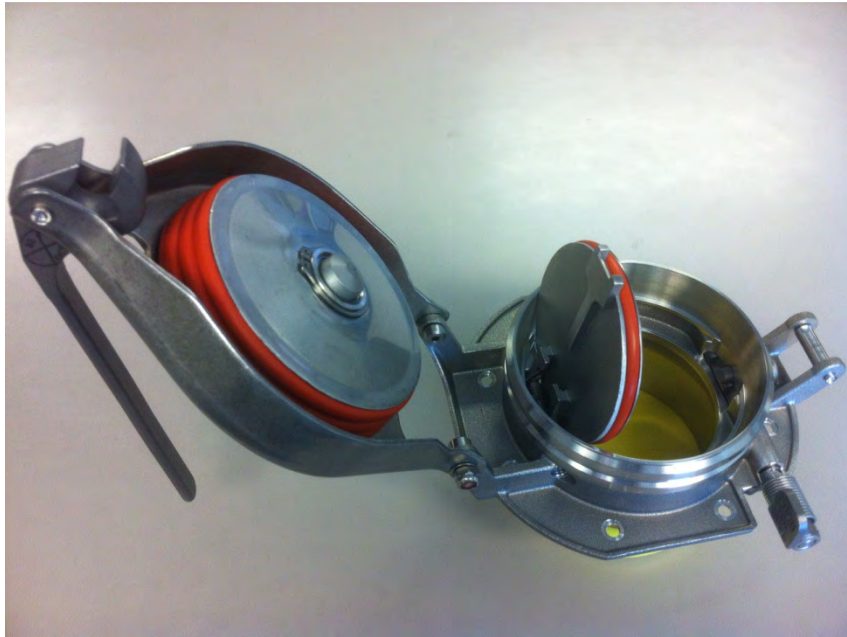
The spring loaded internal fluid valve opens with the small external lever AFTER the ground service cart duct is connected. No more mess if the tank valve leaks.

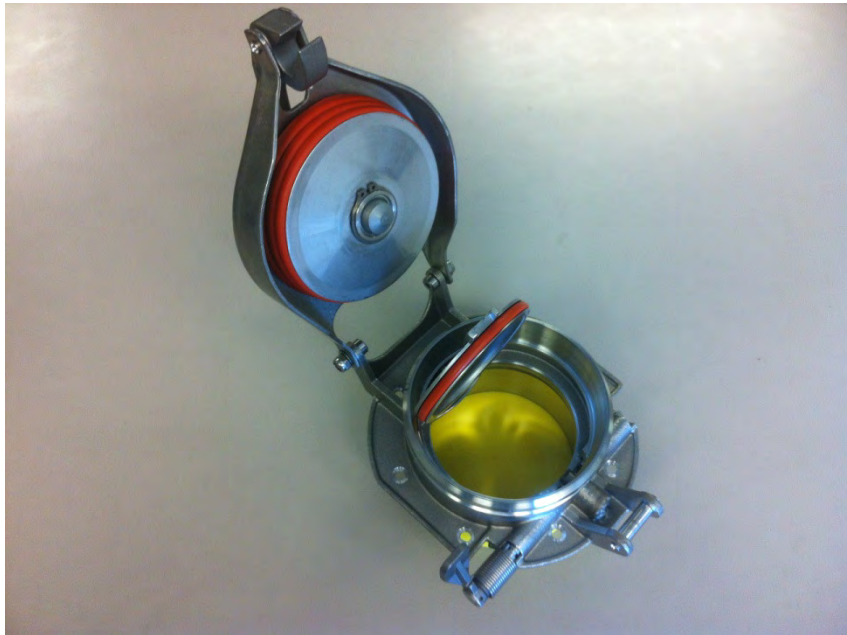
Closing the internal valve is as simple as closing the cap with the over center lever.
