CF34BJ SERVICE BULLETIN - 72-0347 R00
Revised:
05/30
/2025
SB 72-0347 R00 ENGINE - GENERAL (72-00-00) - ONE-TIME COMPRESSOR INNER DIAMETER INSPECTION FOR CORROSION AND VARIABLE GEOMETRY SYSTEM FUNCTIONAL CHECK
Issued: 05
/30/2025**GE Designated: -CONFIDENTIAL-**

SB 72-0347 R00 ENGINE - General (72-00-00) - One-Time Compressor Inner Diameter Inspection for Corrosion and Variable Geometry System Functional Check

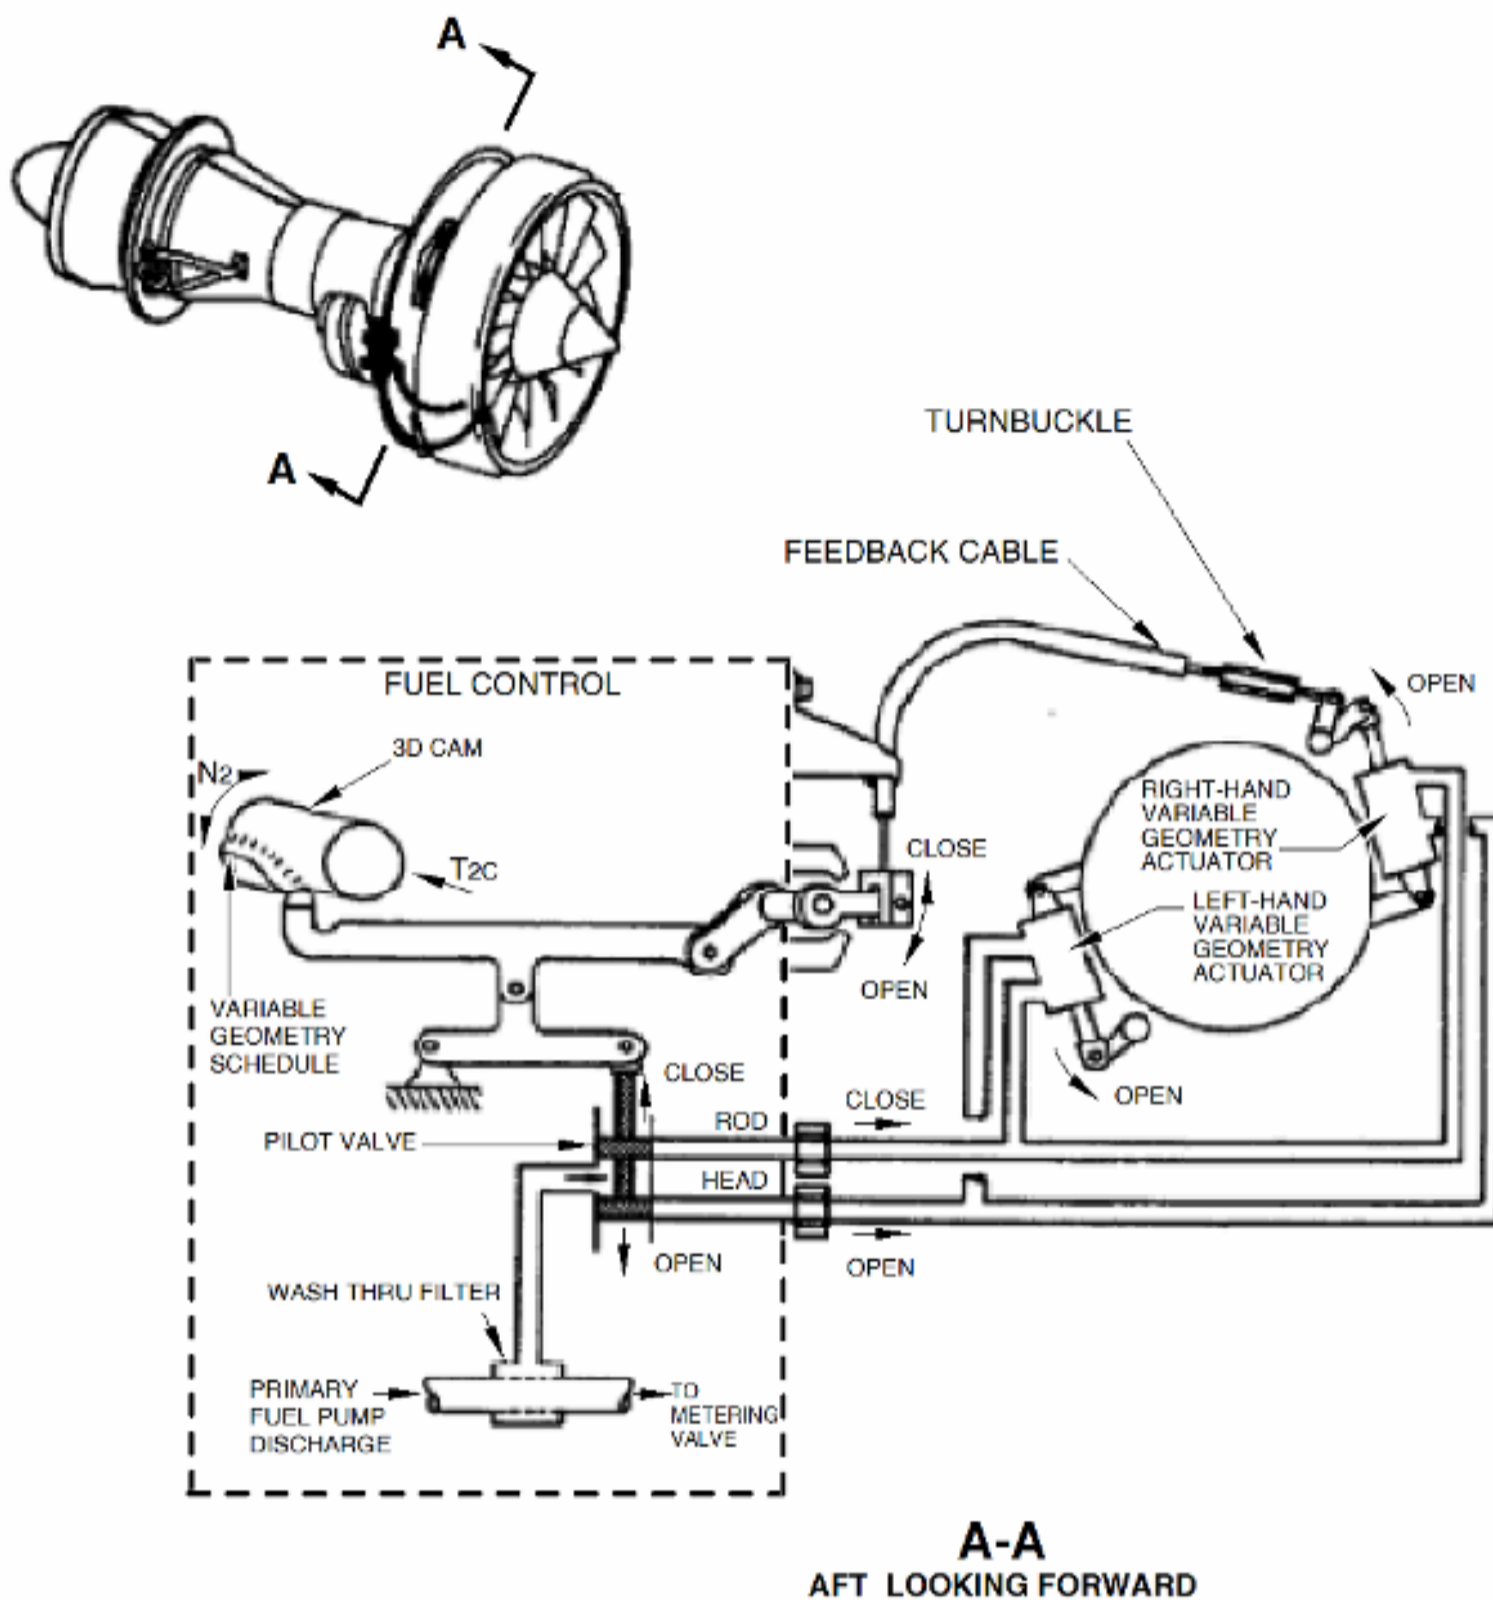
VG System
Figure 2

- (1) Do a functional check of the VG system ([Figure 2](#)) in accordance with the applicable SEI-580, 72-00-00, SPECIAL MAINTENANCE PRACTICES, paragraph 14, Variable Geometry System - Maintenance Practice 68 or SEI-780, 72-00-00, MAINTENANCE PRACTICE 68.
