Outboard Trailing Edge Box Wing Rebate Flanges — Special Detailed Inspection

G450 AMM 57-50-00

GIV AMM 57-50-00

CMP 575019

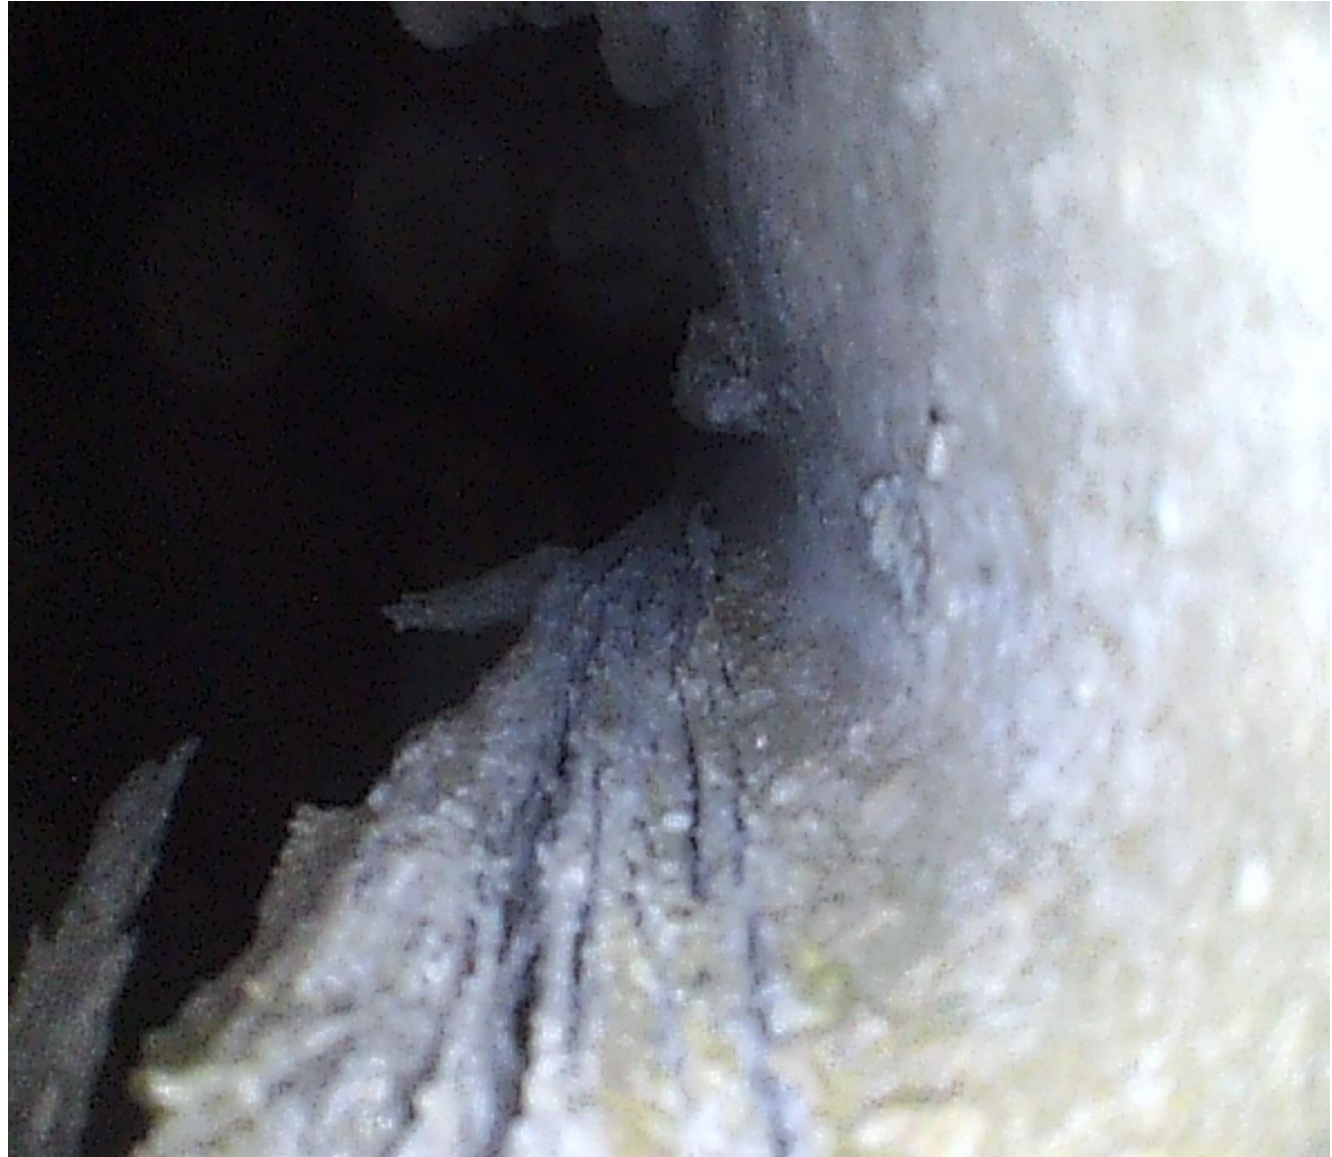
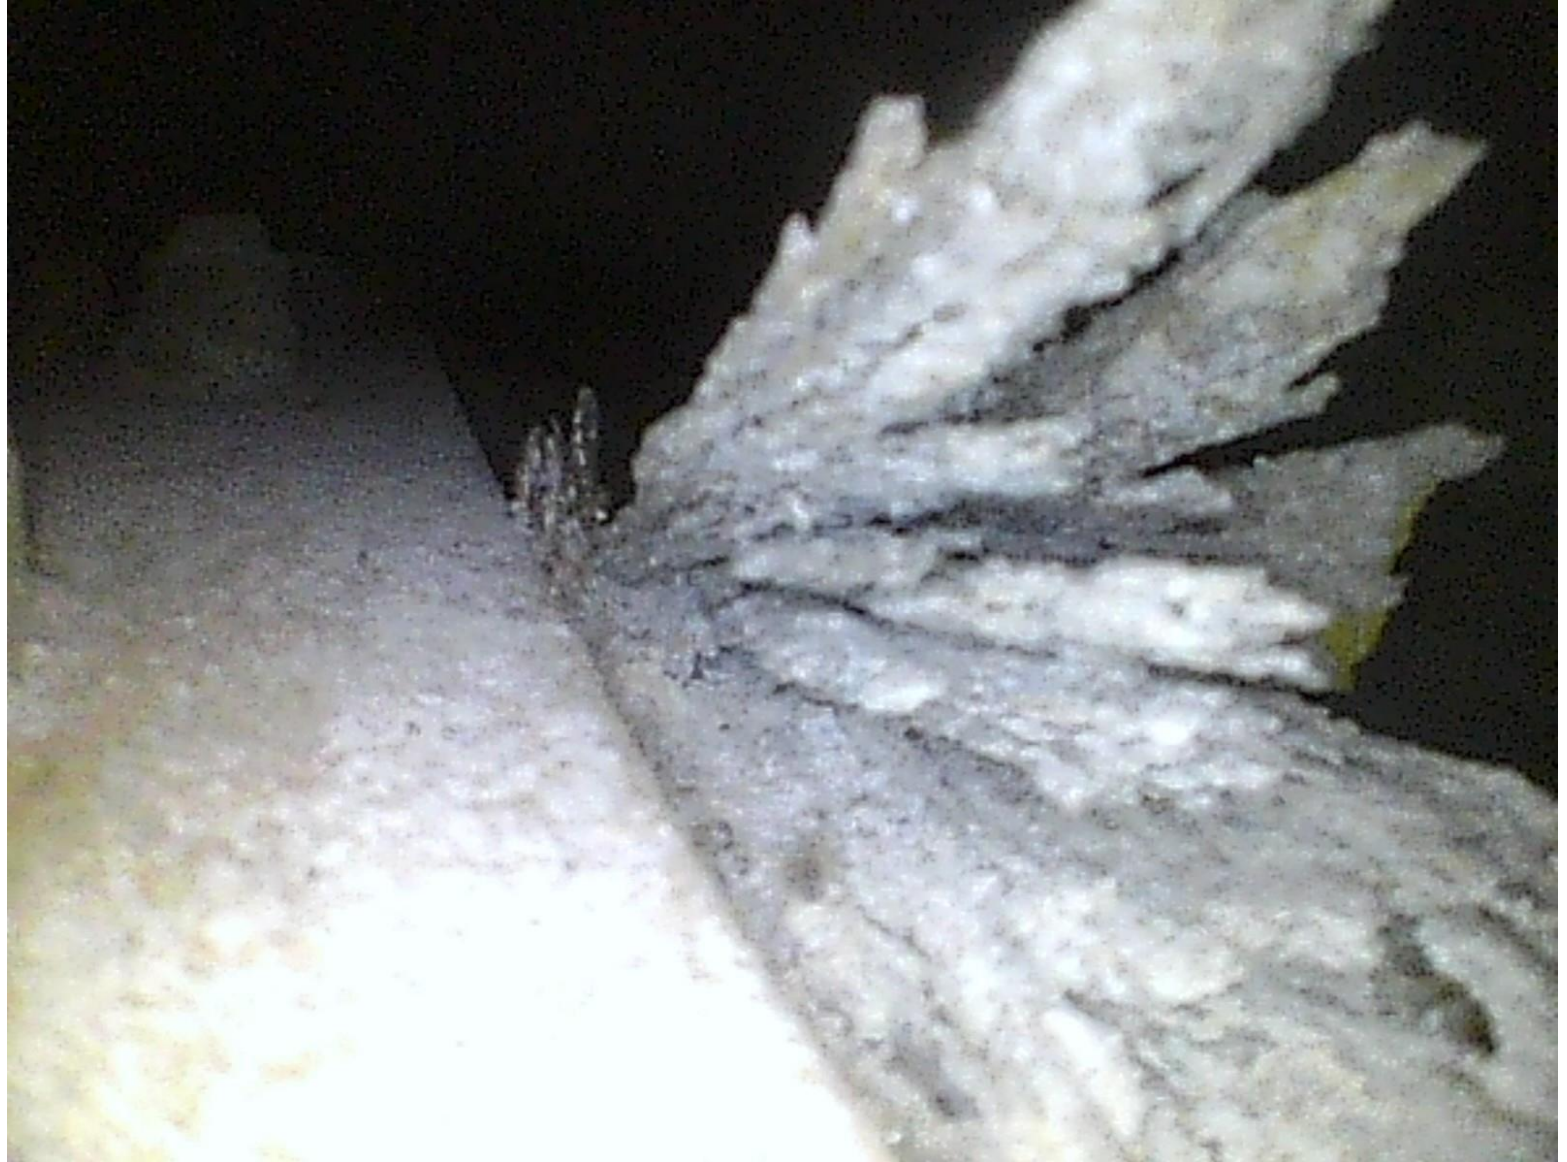
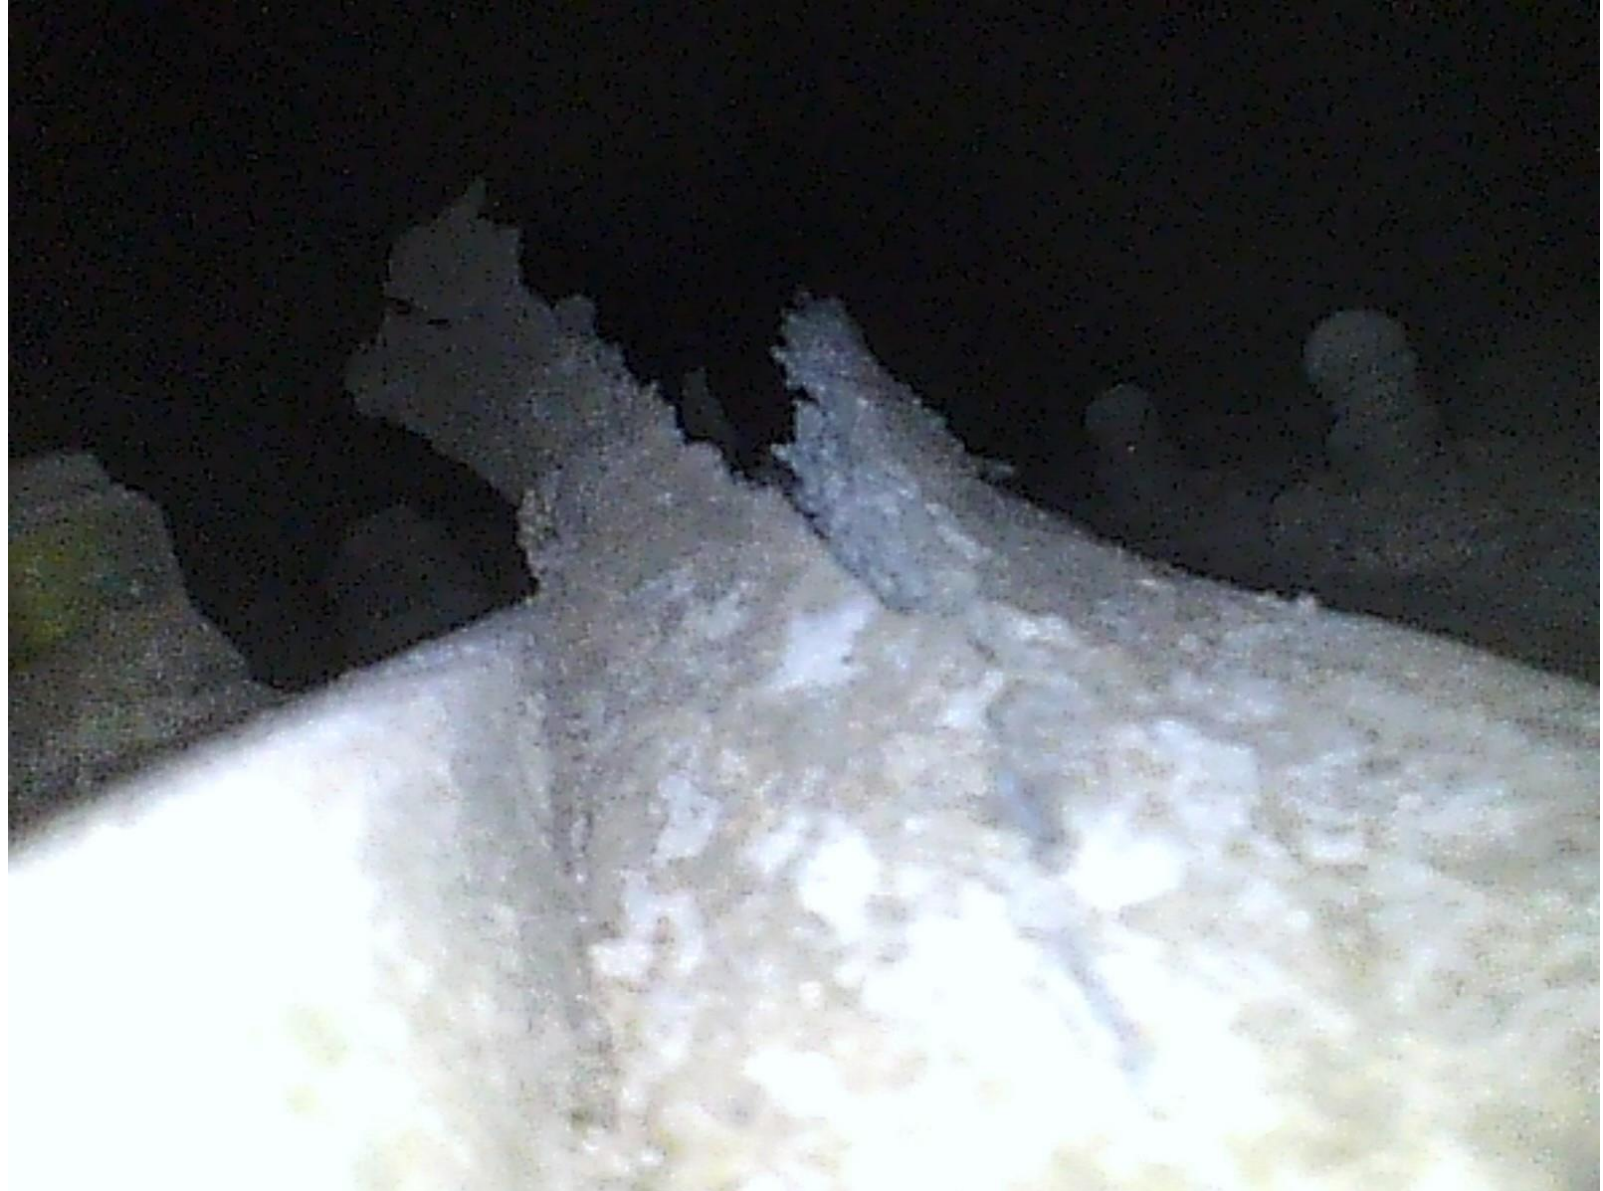
Approximately 6 inch from beginning of crack, exfoliation and crack stop.

- Cut out Corroded area per ENG. Documents
- Make plaster mold casting and send into repair control
- Repair control then makes a 3D print as well as first test piece
- Verify manufactured piece fits as stated in ENG. Documents
- Resubmit new mold if any defects noted. This process can take multiple molds
- Once verified install one piece CNC milled doubler on outside of wing skin plank.
